HISTORIC RESOURCES COMMISSION STAFF REPORT

COA NUMBER: COA23-46

Project Title: 107 Gillespie St Facade Strengthening
Application Type: 6.1) Certificate of Appropriateness
Workflow: Major Work

Front Façade Strengthening

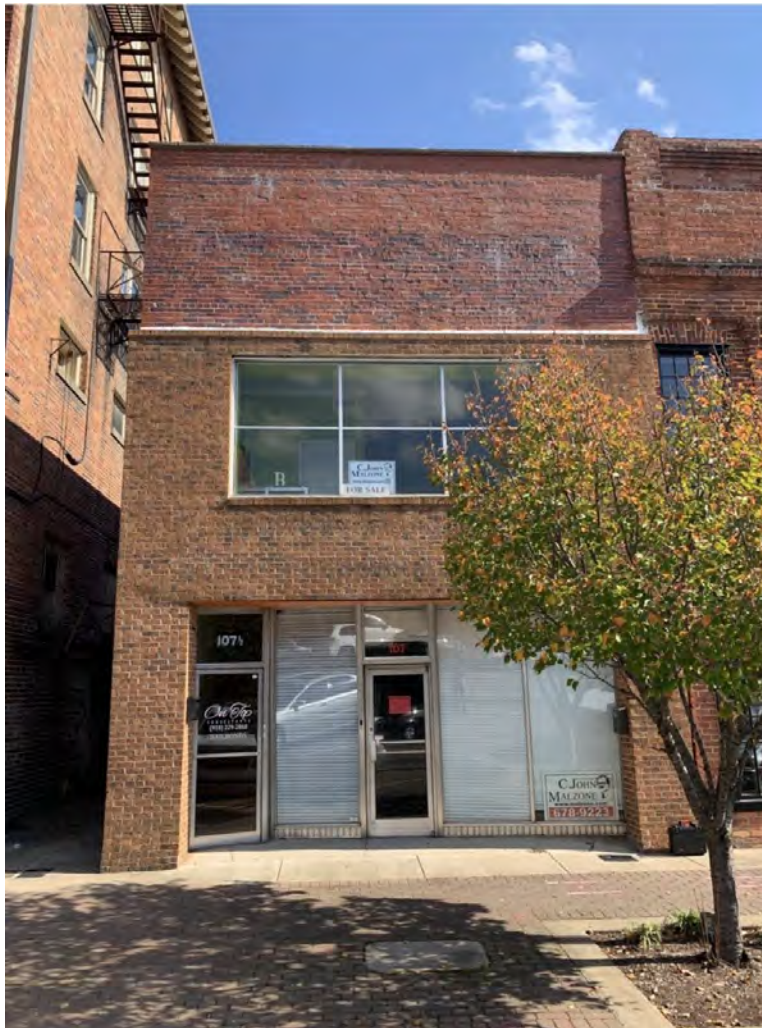
107 Gillespie St
Fayetteville NC 28301

The applicant is requesting a Certificate of Appropriateness to remove the existing steel angle beam that supports the brick façade located under the second-floor window. The applicant is requesting to replace the steel angle beam with an 8” I-beam spanning the width of the storefront. The applicant states the existing steel angle beam is “deflecting from years of weathering and wear”. The applicant is also requesting to install two helical anchors under the two front pillars. Once installed, the helical anchors will not be visible. This work is intended to be a preventative measure against future deterioration.

The applicant does not expect to remove any bricks from the front façade during the removal of the steel angle beam and installation of the replacement I-beam. Any bricks that are removed will be saved and replaced. Some bricks may need to be temporarily removed from the inner-facing side of each pillar to ensure the new beam contacts the original bricks. Once the work is complete, the bricks will be replaced.

Concrete around the front pillars will need to be removed in order to install the helical anchors. The concrete will be repaired/replaced and if any paver stones are removed, they will be replaced as required. The work should not involve the removal of any brick from the façade of the building. According to the applicant, the work will take one day.

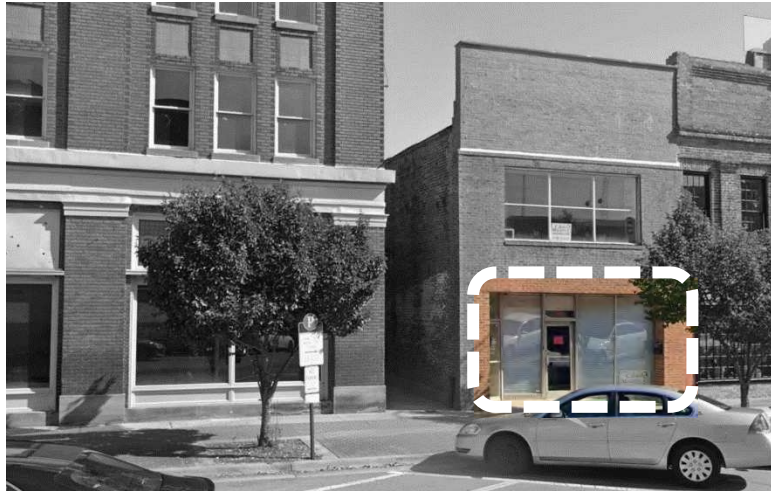
PUBLIC VISIBILITY

The proposed work will be viewable from across Gillespie St. and from Hay St. The 8” steel beam will be placed across the top of the storefront and may be visible from a distance. The presence of the beam will not detract from the professional appearance of the building.

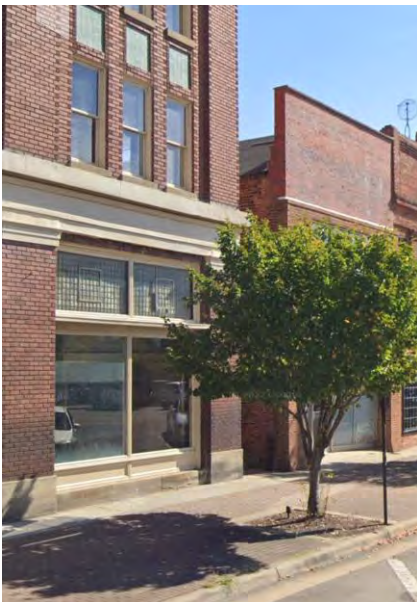
Market House View

The front façade and windows of 107 Gillespie St. is mostly hidden from the public's view due to neighboring structures, parking, or the side-walk trees.

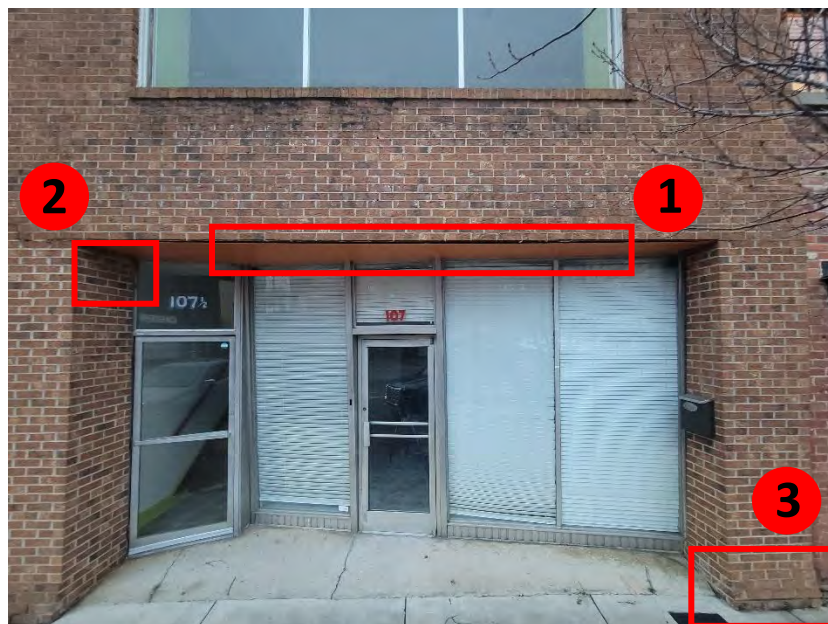
CURRENT CONDITION

Current deflection can be seen in the steel angle [1] leaving part of the brick façade with limited support. This condition is not a rapidly progressing issue and has appeared this way for years. The brick façade (estimated to be installed in the 1960s) is most likely fastened independently to original bricks of the building (1900).

During installation of the steel I-beam, bricks on the inner facing pillars [2], may have to be cut-out and put back after completion. Below each pillar [3], a helical anchor will be installed but will not be visible to the public. All helical work will be below surface and will be completed without interfering with façade.

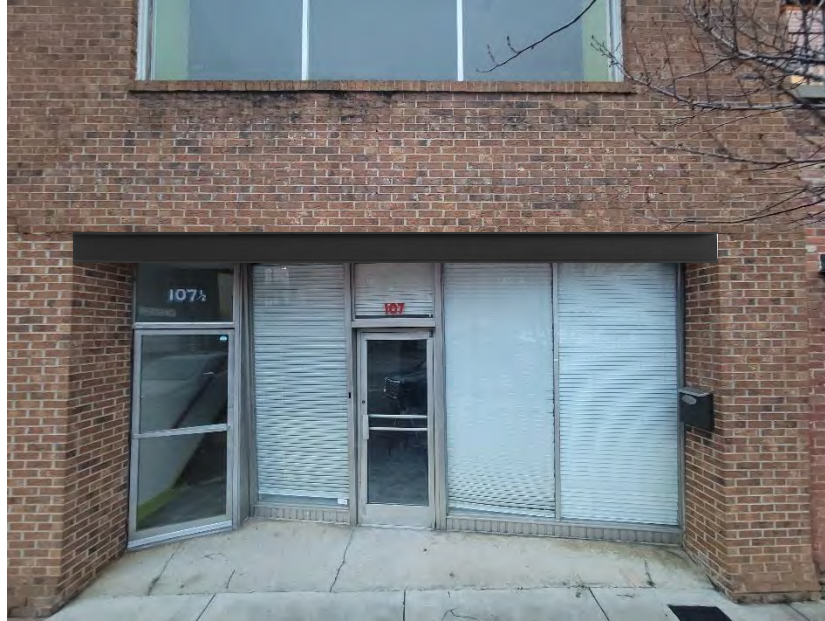
PROPOSED CONDITION

The front brick façade of the building will have the current steel angle beam removed and replaced with an 8" I-beam spanning the width of the storefront. The section of brick façade at the front of the building, immediately below the second floor window, has limited support due to the steel angle deflecting from years of weathering and wear. The building nor its façade display any indications of instability or risk of partial collapse. Additionally, two helical anchors will be placed under both front pillars. The helical anchors will not be visible to the

The applicant is requesting a Certificate of Appropriateness to remove the existing steel angle beam and replace it with an 8" black I-beam spanning the width of the storefront. The applicant also plans to have two helical anchors placed under both front pillars of the building.
